Experience and challenges in the inspection of horticultural and ornamental sprayers (Flanders-Belgium)

Spise 8 workshop the Netherlands

May 2023

ILVO Flemish Institute for Agricultural and Fisheries Research

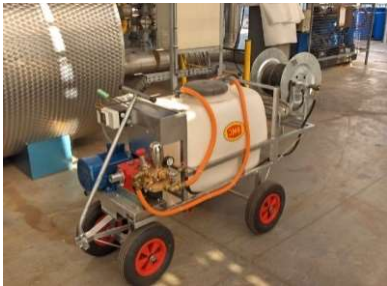
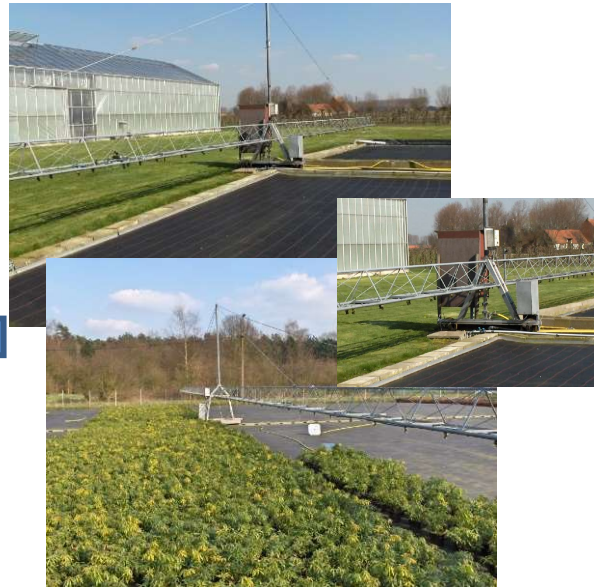
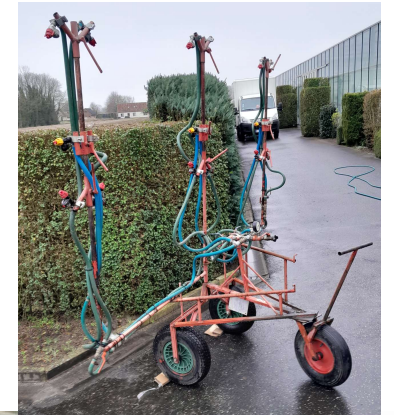
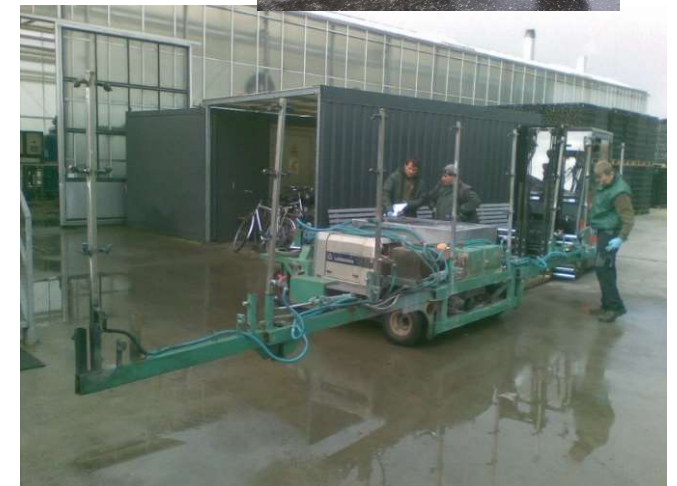
Main issues concerned:

- Equipment with one pressure unit and multiple separate booms
- Equipment with booms with different vertical branches
- Price settings

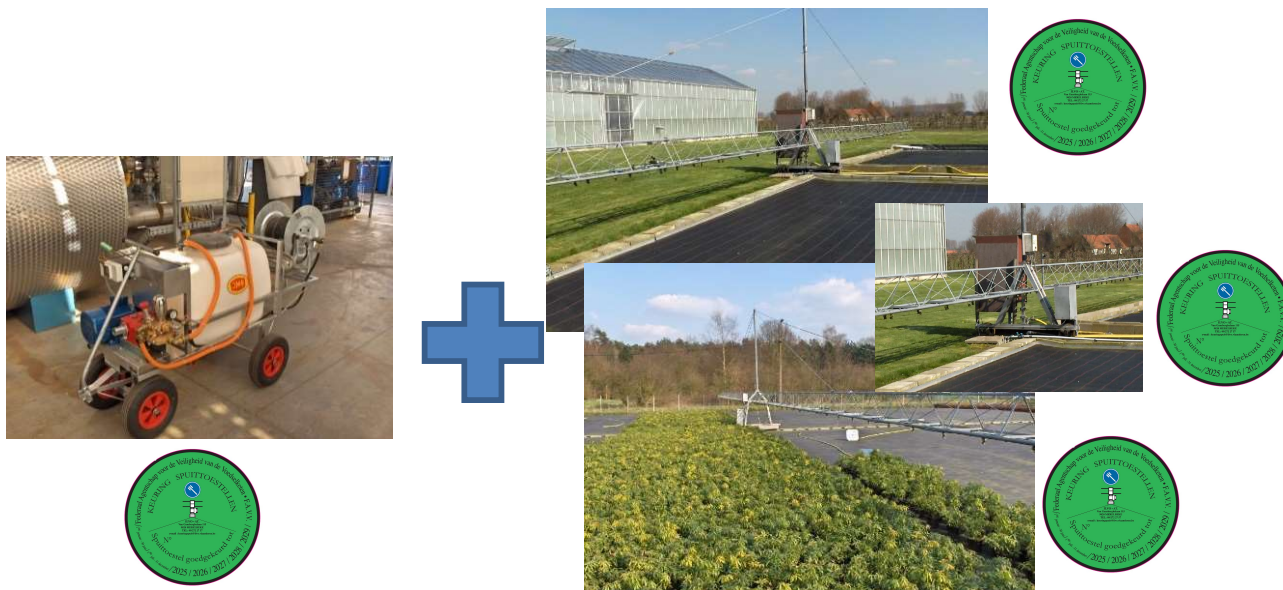
One pressure unit and multiple separate booms:

- Chose to see pressure unit(s) and booms as separate PAE
 - Certification report and sticker for each separate part
 - Traceability (third party inspections)
 - Interchangeable

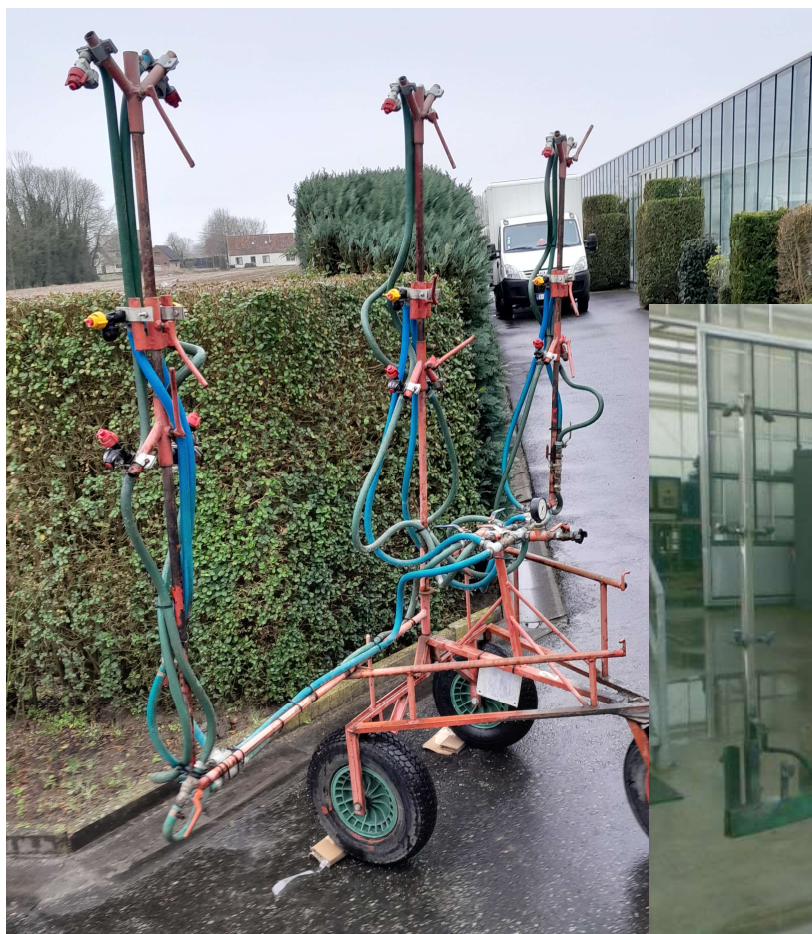
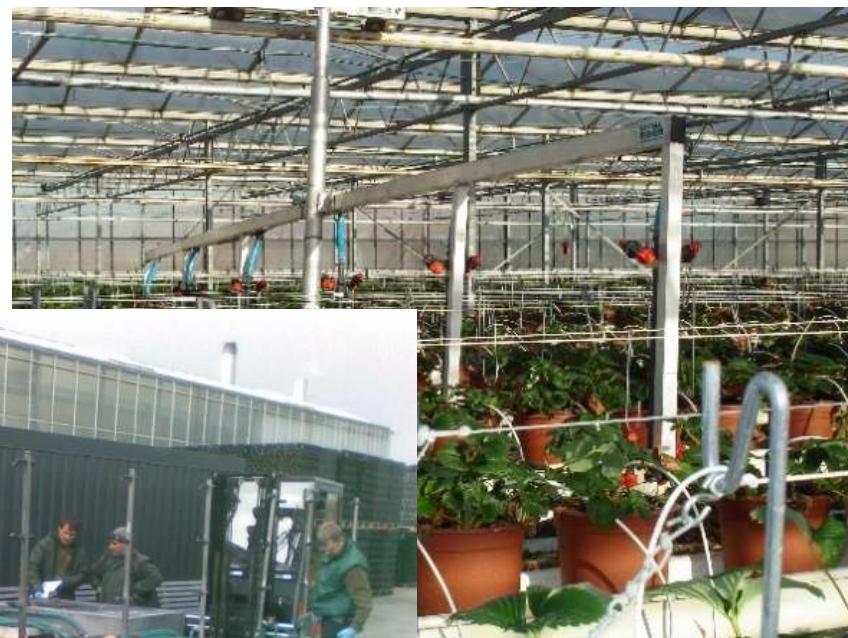
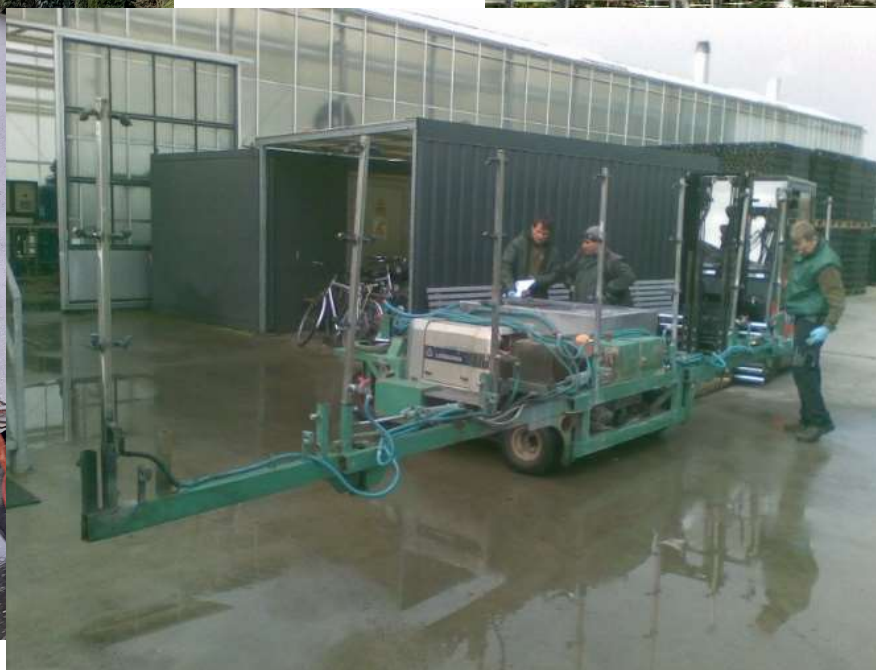
Equipment with booms with different vertical “branches”:

- Horizontal bearing boom:
 - Is inspected as a normal horizontal boom (curvatures, hinges, ...)
 - Distance tolerances between branches were added
- Vertical branches:
 - Are inspected as individual vertical booms

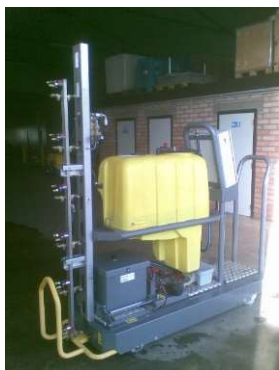
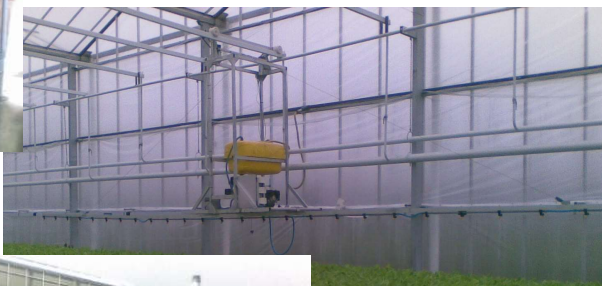
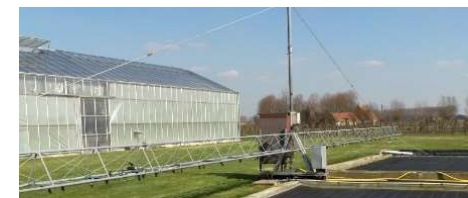
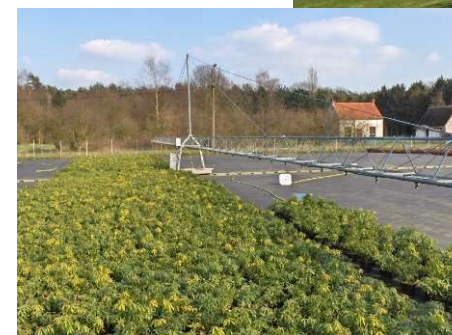
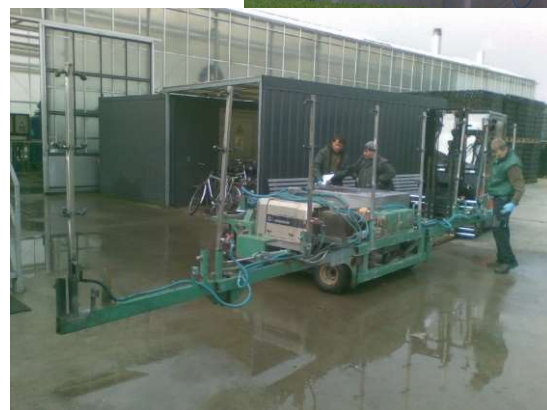
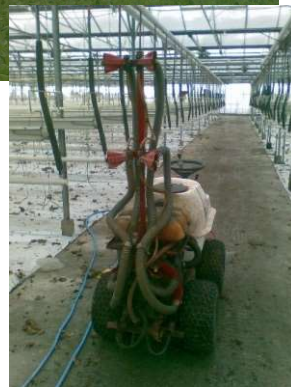
Price settings:

- For PAE with boom fixed to pressure unit:
 - Prices are identical to field crop sprayers (boom width in meter)
 - Depending on the number of nozzles on the PAE divided by 2
- For PAE with separate booms:
 - Other (lighter) prices for the separate booms → less work
 - Depending on the number of nozzles

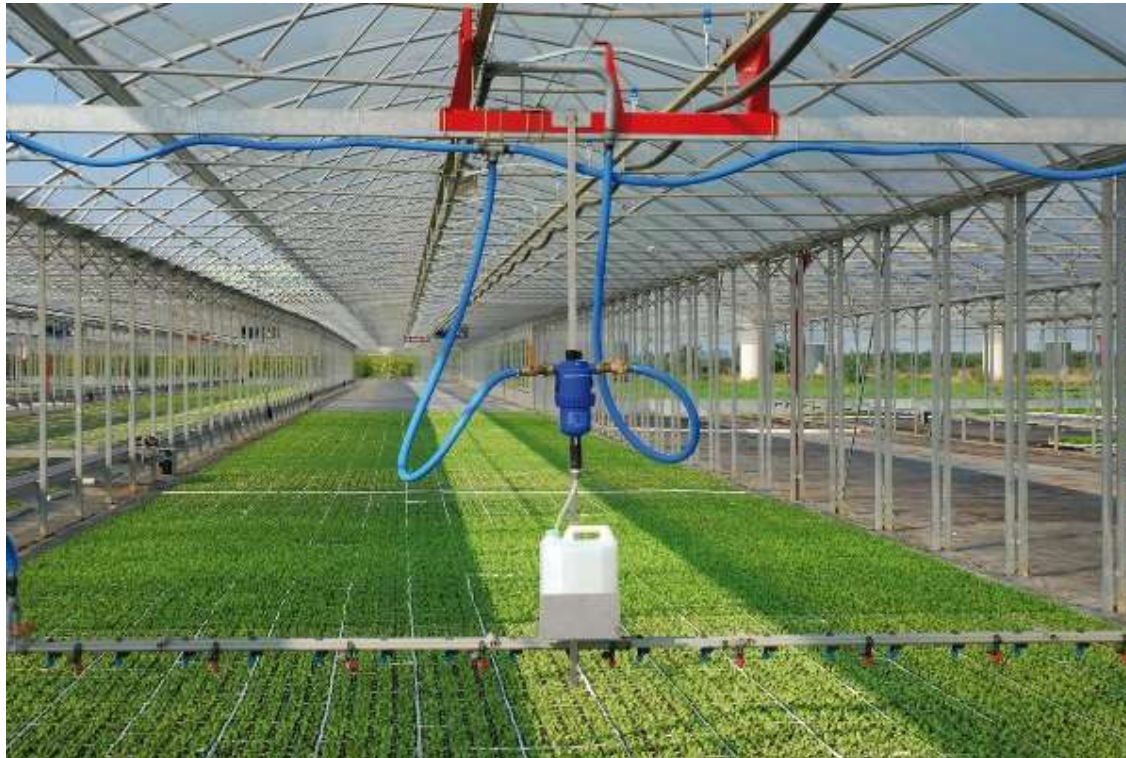
Testing injection systems (dosatron, ...):

- No experience with those systems
- A new (simple) test procedure was defined

- 1) Instellen en aflezen dosering.
- 2) Aanzuig dosatron ofwel:
 - In maatbeker en vaste hoeveelheid bv 500ml laten opzuigen
 - Vanuit tank met vaste hoeveelheid water vullen.
- 3) Flowmeter op 1 dop en op de spuitboom. (dop=gemiddeld debiet)
- 4) Toestel laten spuiten en bij opstart dosatron ook flowmeting opstarten.
- 5) Wanneer de vaste hoeveelheid water aanzuigtank dosatron werd verspoten, flowmeting stopzetten.
- 6) alle waarden ingeven

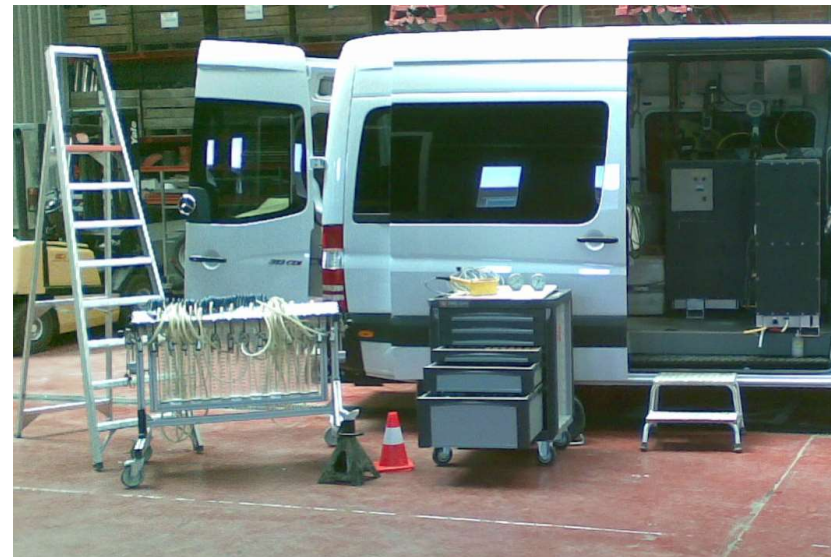
- Same equipment used for field crop and orchard sprayers.
- No extra investments needed.
 - Nozzle test bench,
 - Pressure sensors,
 - ...

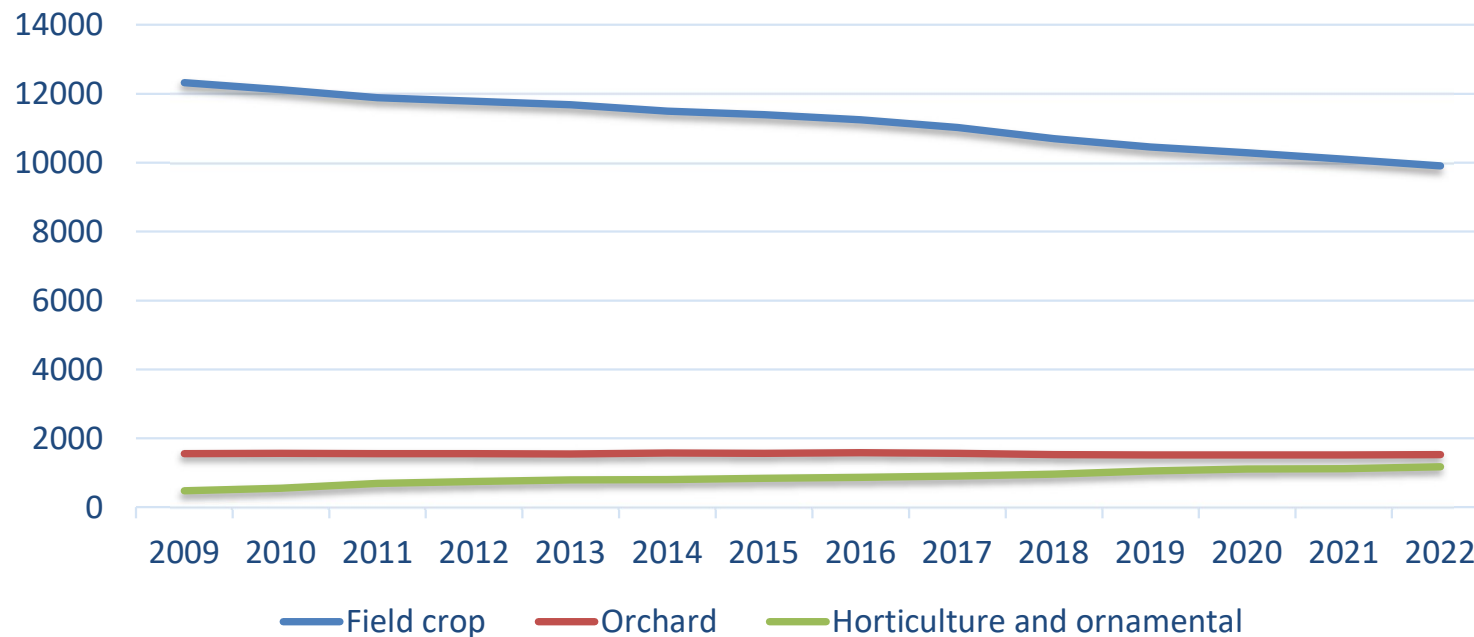
Number of sprayers (Flanders)

Evolution of the amount of inspected sprayers:

- Increasing number of horticultural & ornamental sprayers (still ongoing!)
- Actually +/- 1.200
- Mix of all type of equipment

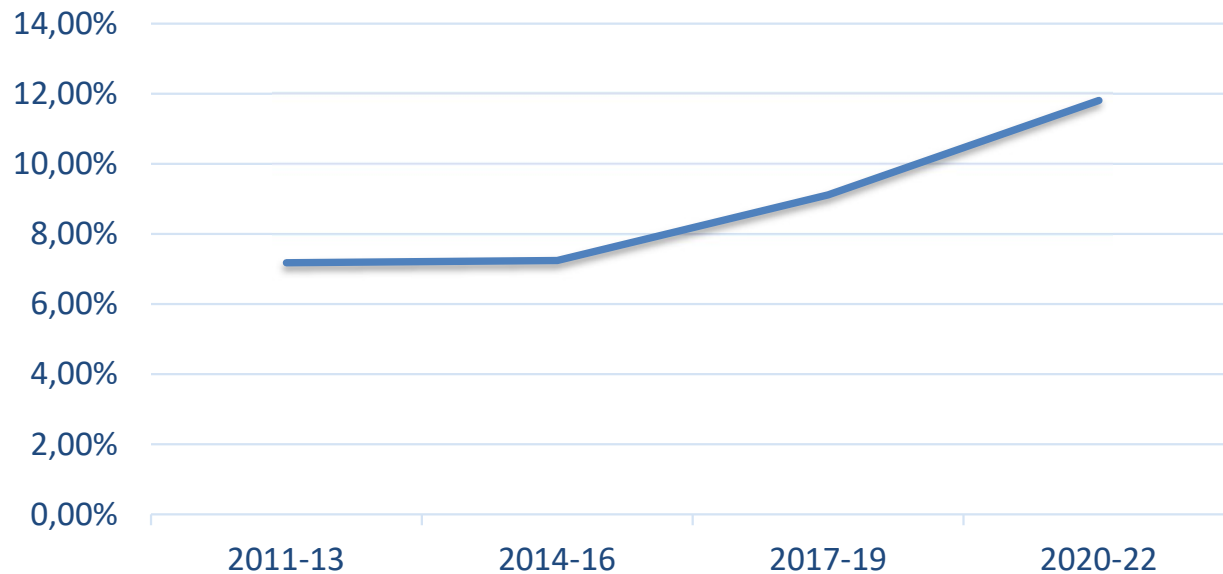
Procentually rejected

Evolution of the number of rejections:

- Increasing percentage of rejections due to tightening of the inspection protocol

Totally inspected	Rejected	Procentual
2011-13	697	50	7,17%
2014-16	815	59	7,24%
2017-19	911	83	9,11%
2020-22	1109	131	11,81%

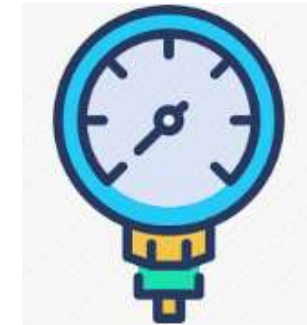
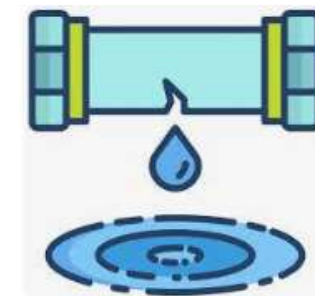
Major defects=rejections (Class I: to be repaired):

- Same top 3 as with field crop and orchard sprayers
- Increasing number of rejections due to:
 - Increasing number of sprayers inspected
 - Tightening of the inspection protocol

ITEM	DESCRIPTION	Total	2011-13	2014-16	2017-19	2022-22
H4	Bad pressure gauge	144	24	30	33	57
L2	Worn nozzles	98	20	21	24	33
N1	Leakages	71	10	5	22	34
G1	Torn air clutch membrane	23	6	7	6	4
I	Pressure unbalance	22	1	1	8	12
H1	No pressure gauge	17	2	3	1	11
N3	No anti-drip device	15	0	0	0	15
L1	Nozzle set not homogene	12	1	3	0	8
M4	Valves not closing	8	0	0	5	3
G4	Bad working pump	7	0	0	1	6
M5	Bad working pressure valve	3	0	0	3	0
M3	Bad working spray rate controller	3	0	0	1	2
D3	Spray boom curvature	2	1	0	0	1
A3	Fan in bad state	1	0	0	0	1

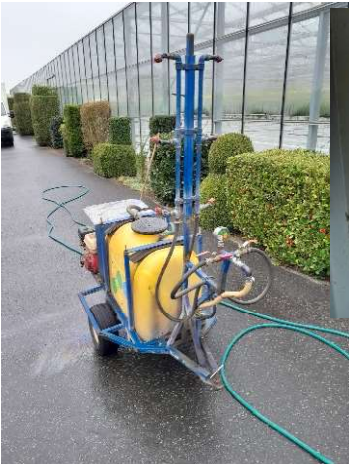
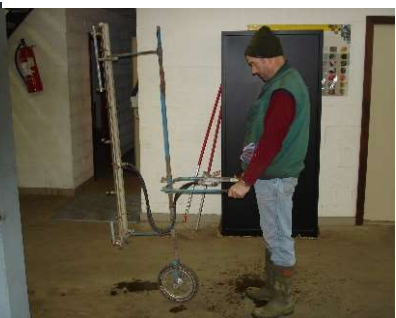
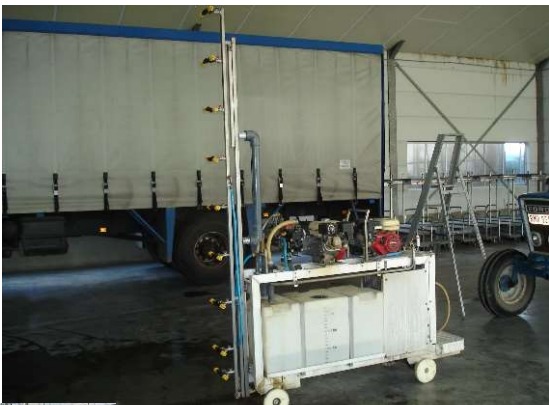
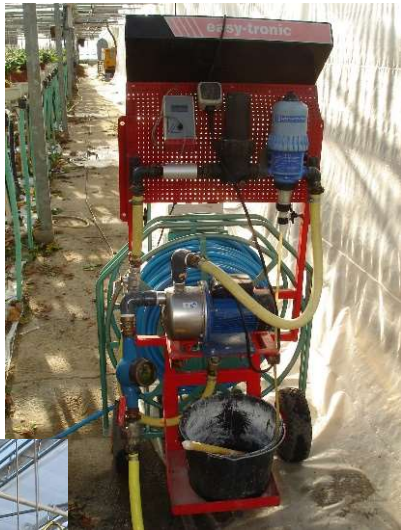
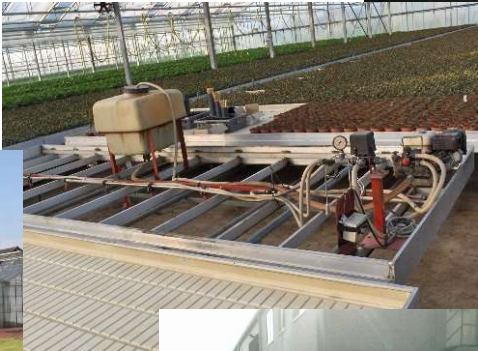
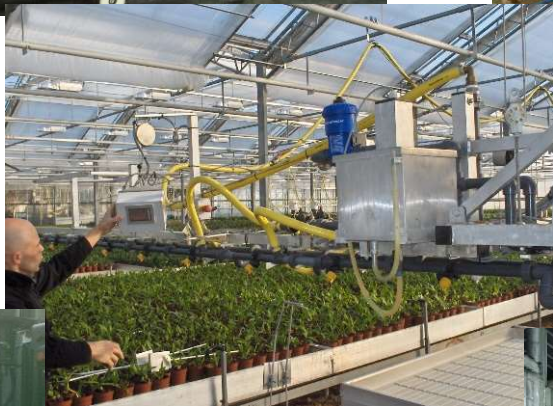
- Horticulture and ornamental PAE → Broad variety of PAE and combinations!
